10 South Riverside—Glass Stair for Corporate Office

10 South Riverside—Glass Stair and Partition Design Chicago, Illinois

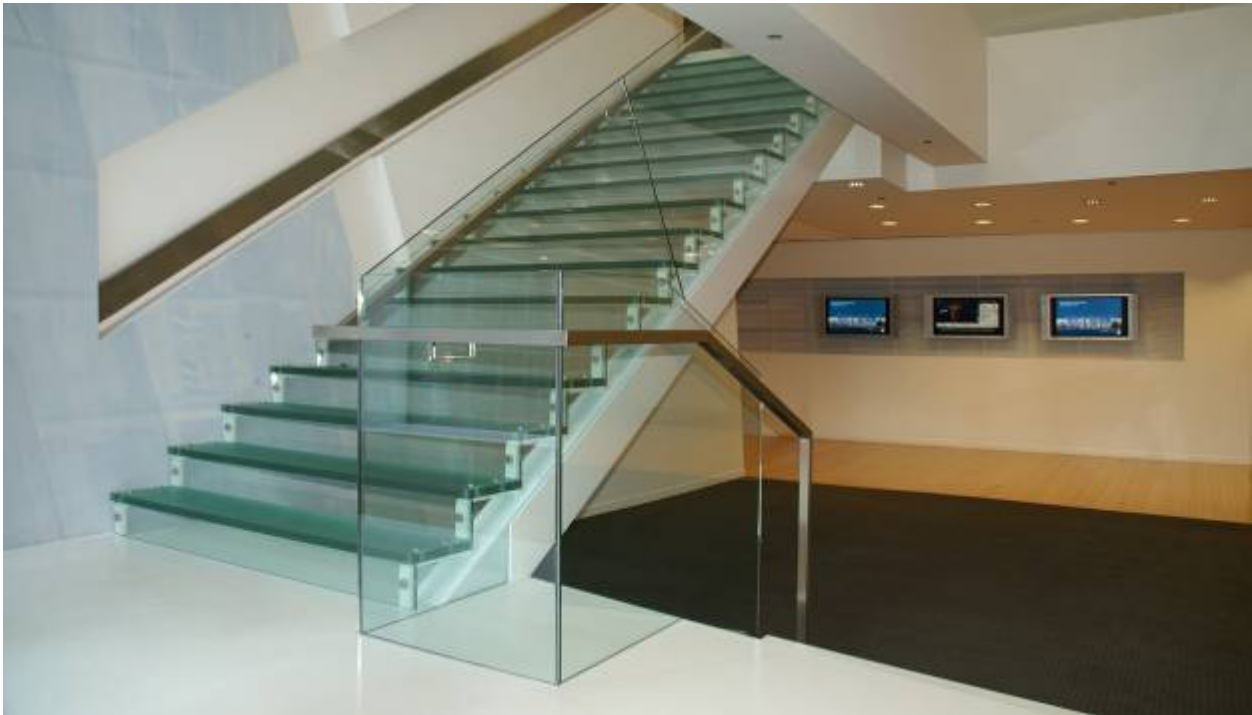
Phase I: In 2004, a new glass stair was designed and installed in this downtown office building to meet a new tenant’s aesthetic and functional requirements by connecting two floors and thereby creating a more open and luxurious space. The scope of the project included hanging glass partitions as well as other structural tenant modifications. The Structural Group’s design encompassed cutting openings in the floor slab and reinforcing the existing structure to accommodate the new stair and partitions. TSG also coordinated the design of the glass stair and partitions with the glass manufacturer. The stair consisted of glass treads and risers, joined by stainless steel connections, supported on a steel tube stringer and a skewed sloping partition wall.

Phase II: In 2007, adjusting to the needs of a new tenant, The Structural Group provided the design to “in-fill” the openings in the slab, which were cut when the stair was installed (Phase I), with new framing. The glass stair was permanently removed from the building; the glass partitions remain in place.
